Site 186 Page-Potter Marsh / Rust Island

Great Marsh Coastal Wetlands Restoration Plan
Rapid Technical Assessment Site 186

Site # 186

Page-Potter Marsh/Rust Island

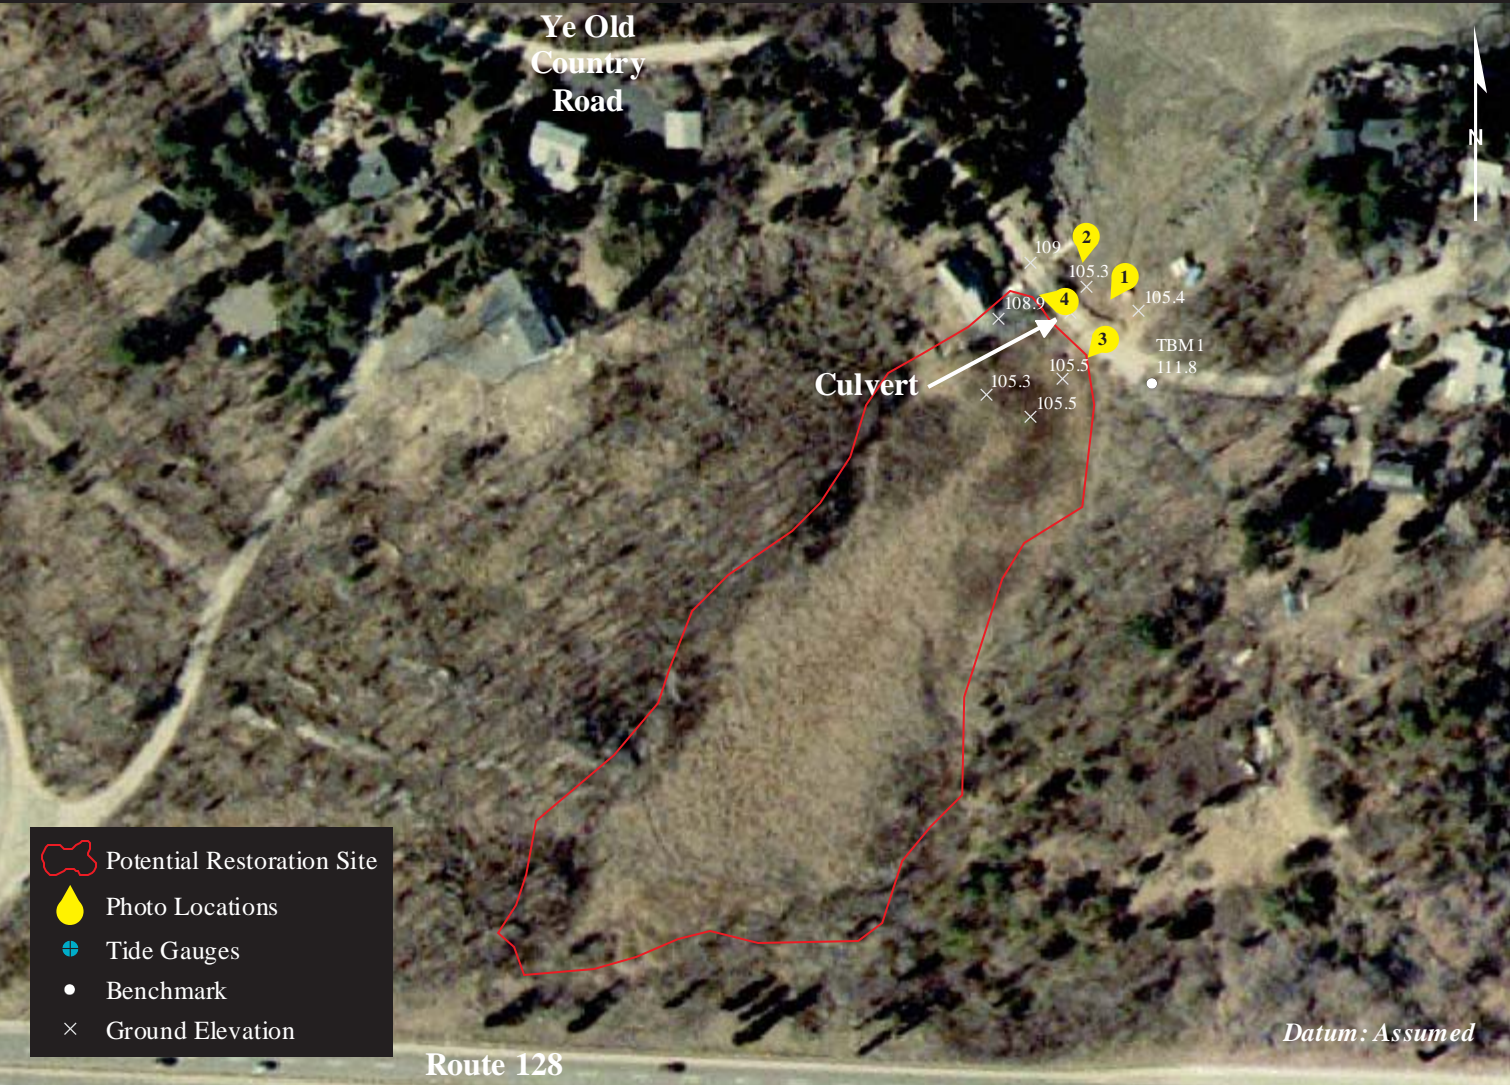
Structure conditions: Limited tidal flows to the potential restoration site are conveyed under Ye Old County Road via an 18 in CMP culvert. A portion of the downstream pipe has been lost due to corrosion. There is no formal riprap protection at either end of the culvert; however the rocky beach at the downstream end does provide some scour protection. Ye Old County Road in the area of the culvert is in fair condition. The downstream side of the road will shortly require some level of protection to address continued coastal erosion. There are indications that the culvert is beginning to weaken and collapse (pavement cracks, settlement, patching). The overall condition of the culvert and Ye Old County Road is poor. The existing culvert has been in place for over 35 years. The life expectancy of the 18 in CMP culvert is estimated to be less than 5 years.

Photo 1 - Downstream View of Culvert

Restoration at this site would consist of replacing the existing 18 in culvert with a larger structure placed at a lower elevation (approximately 48-60 in culvert or small box culvert), removing accumulated sediment in the upstream marsh, and constructing a creek system. The relatively low elevation of the road bed may influence available culvert options. Replacement of the existing culvert will require phasing to maintain limited access through the construction site as no detours exist. Low ground pressure equipment will be required for work on the marsh. Material removed from the site will have to either be disposed of on site (reducing restoration area), or hauled off site to a suitable disposal location.

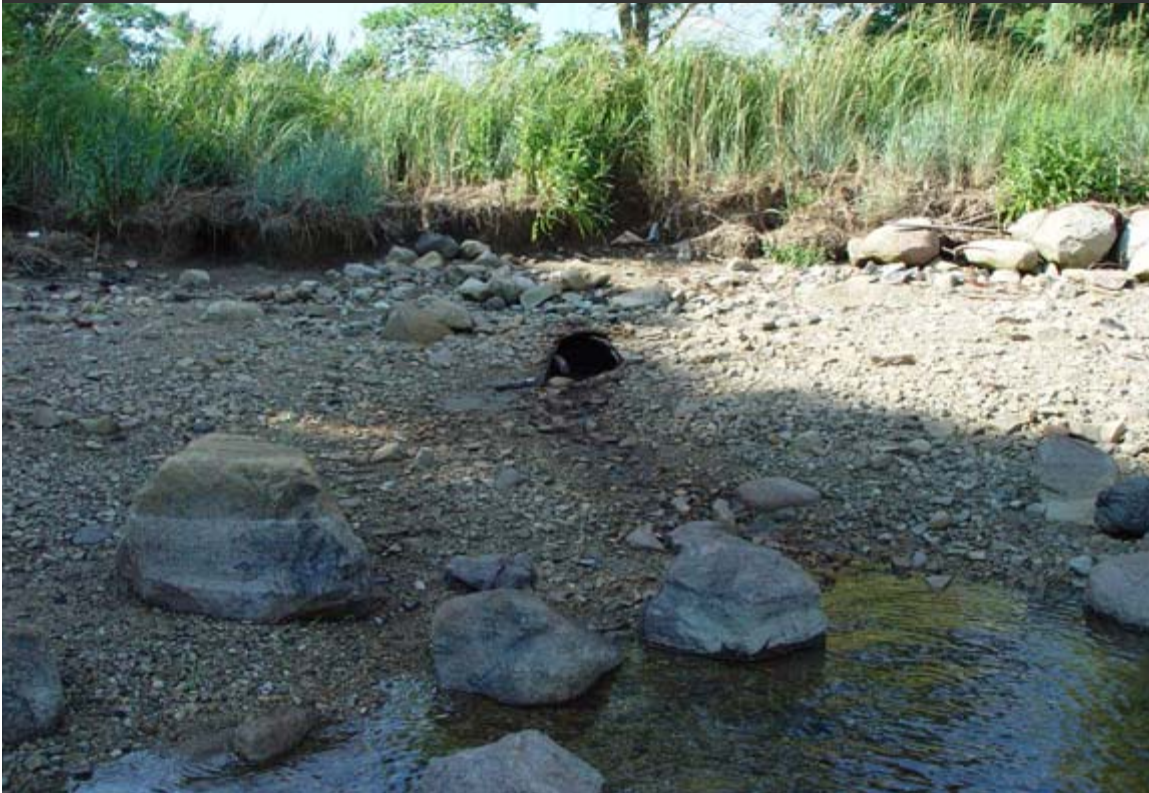
Photo 2 - Downstream View of Road Crossing

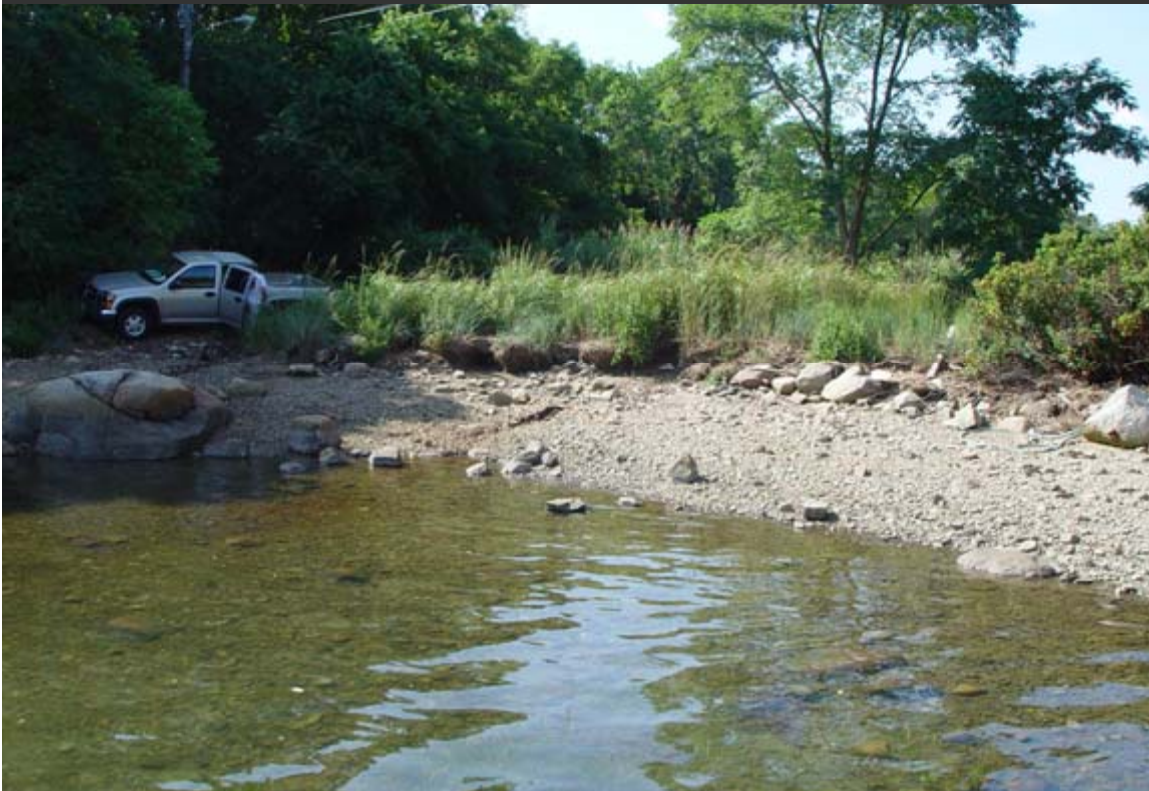
The potential restoration site is nearly entirely a monotypic stand of tall *Phragmites* with a few very small remnant patches of high marsh vegetation. The wetland occupies a well-defined topographic depression which rises abruptly to forested uplands to the east and west and the

Photo 3 - Site Viewed from Road Crossing

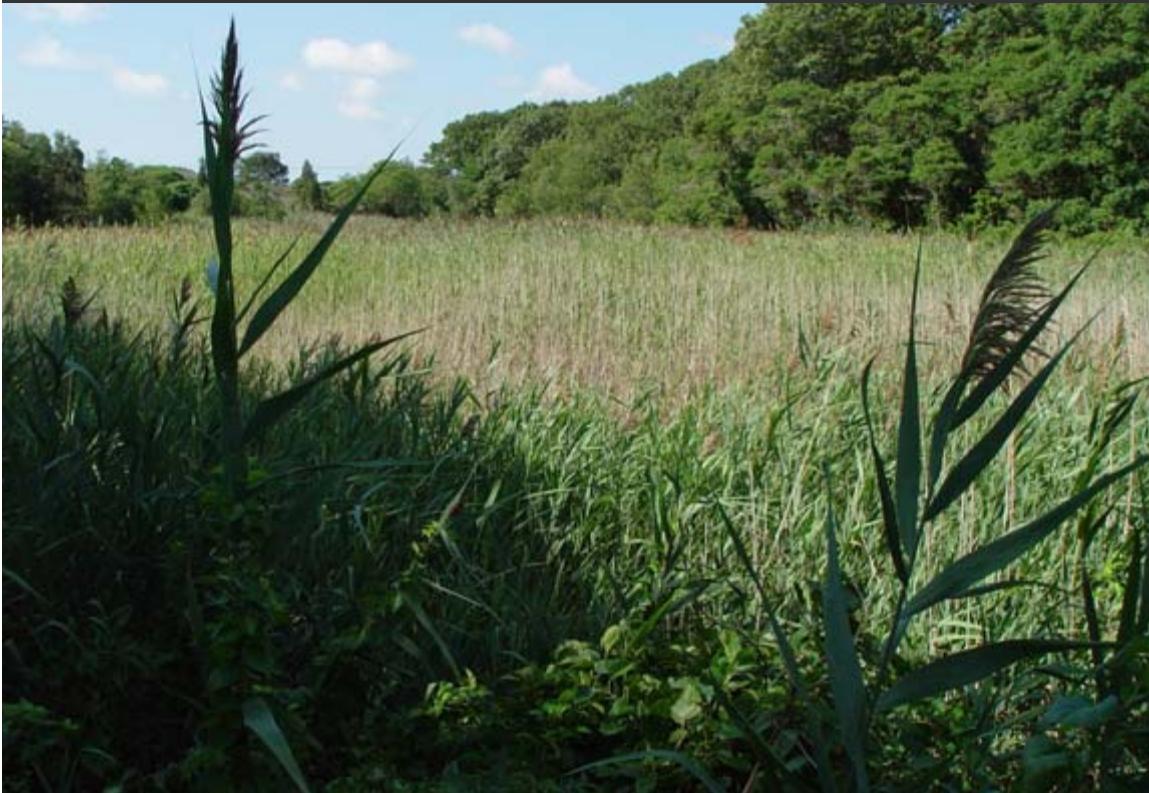
The overall severity of the existing impairments is considered severe. A reduction in the tidal restriction with the replacement of the existing culvert with a larger structure, set lower in the channel, would have limited benefits in controlling the monotypic stand of *Phragmites* due to existing ground elevations. The restoration of salt marsh would also require lowering the existing elevations by a minimum of 0.5 ft and constructing a creek system to allow for the effective circulation of tidal flow and the drainage of freshwater contributions to the system. There are no other adjacent wetlands to the marsh which could be impacted. The single residence on Ye Old County Road is also a factor in the restoration feasibility. The first floor of the structure is approximately 4 ft above the mean spring tide elevation; however the base of the existing underground waste disposal system could be impacted with higher water levels and requires closer examination. The disposal system reportedly consists of a cesspool which is failing by definition due to the fact that the system is within 50 ft of the wetland.

Photo 4 - View of Abutting Property from Road
